# Rapport

Accident survenu le **9 septembre 2006**  
à **Ferrières-en-Brie (77)**  
à l'**avion Robin R 2120 U**  
immatriculé **F-HAPC**

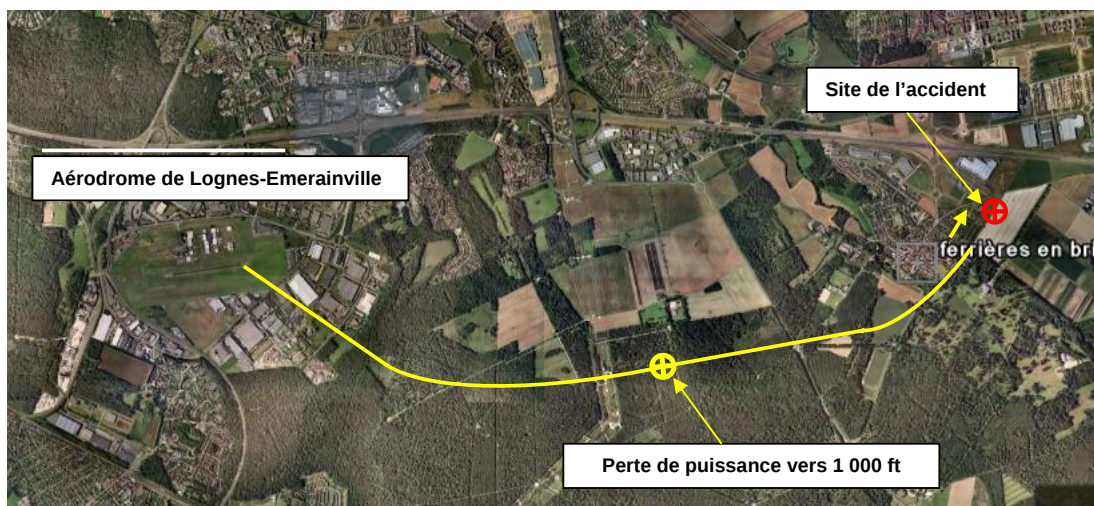
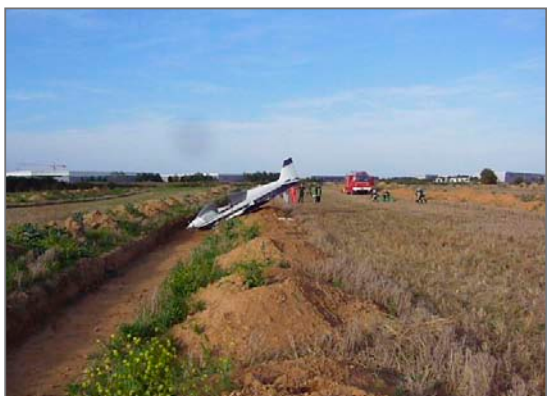
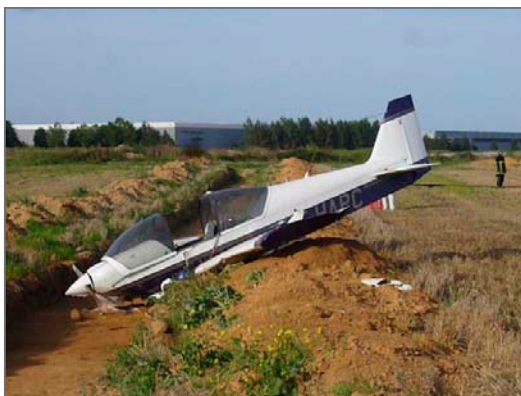
Lors du roulement, le train d'atterrissage s'efface et l'avion s'immobilise dans une tranchée.

La cellule et les ailes présentent de nombreuses déformations dues à l'impact. Le réservoir d'essence contient du carburant. Le moteur et l'hélice sont retrouvés intacts.

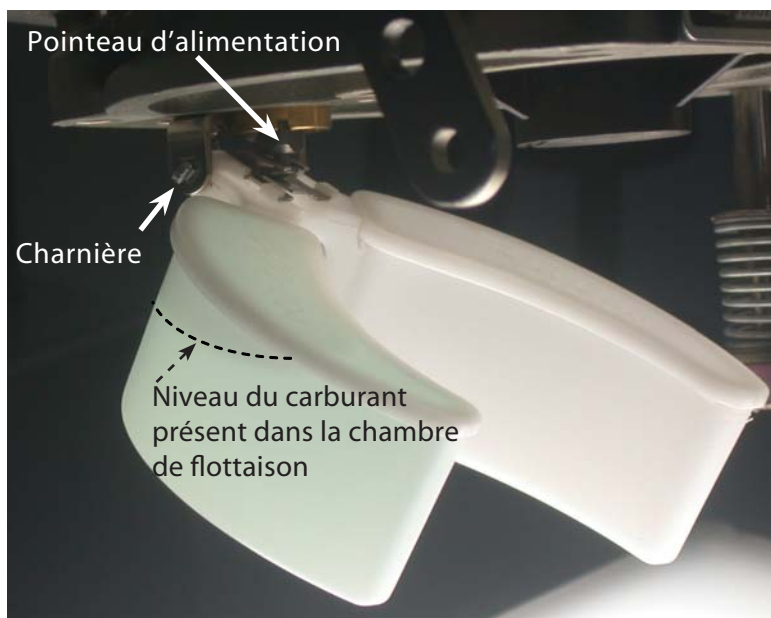
Un examen du carburateur a été effectué. Il a montré une anomalie au niveau du flotteur. Ce flotteur, en forme de fer à cheval, comporte deux chambres de flottaison creuses indépendantes en polymère. Le mouvement du flotteur autour d'une charnière est transmis au pointeau d'alimentation et permet ainsi la régulation du niveau de carburant dans la cuve du carburateur. De l'essence avait presque entièrement rempli une des deux chambres de flottaison normalement étanches et vides de carburant.

La présence d'essence dans l'une des chambres du flotteur du carburateur altère la flottabilité ainsi que l'équilibre de ce flotteur. Ce déséquilibre engendre des forces dissymétriques sur la charnière. Il peut entraver le libre mouvement du flotteur, celui du pointeau d'alimentation et, par conséquent, une variation du niveau d'essence dans la cuve modifiant la richesse du mélange carburé.

Cela est susceptible d'entraîner des modifications de puissance plus ou moins importantes. C'est ce dysfonctionnement qui paraît être à l'origine de la perte de puissance en vol du F-HAPC.
